KITPLANES FOR AFRICA

SERVICE BULLETIN

BULLETIN NUMBER: SB006

SUBJECT: Old fibreglass flaperon chord length

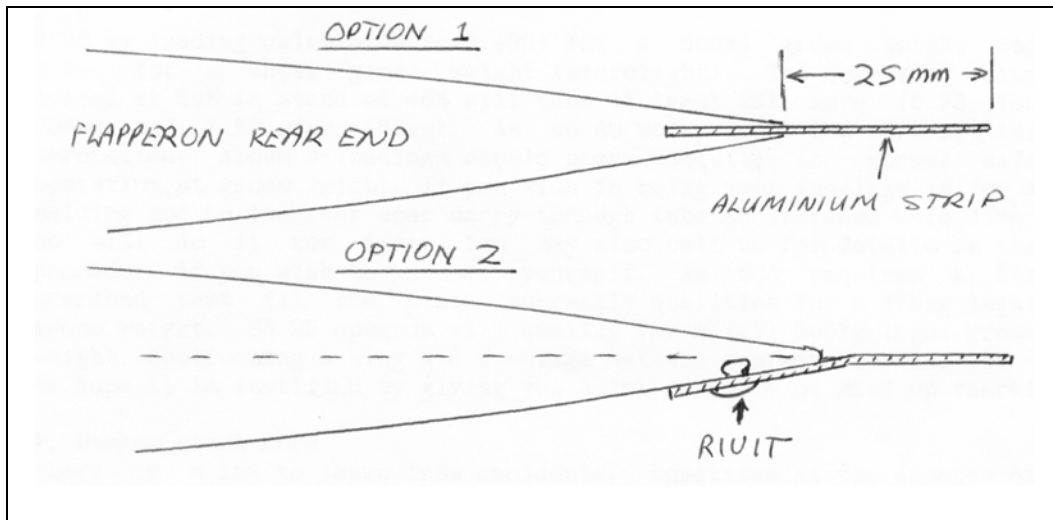
SOLUTION:

PROBLEM: All fibreglass flaperons supplied in early kits up to SN019 have the pivot point at 28% of the chord.

This causes the ailerons to snatch and could contribute to flutter.

A better position for the pivot point is 25% of the chord.

There is an easy rectification for the condition by simply extending the chord line of the entire flapperon length by 25mm.
A strip of aluminium can be bonded or riveted to the trailing edge.
