KITPLANES FOR AFRICA

SERVICE BULLETIN

BULLETIN NUMBER: SB010

SUBJECT: Nose landing gear failure

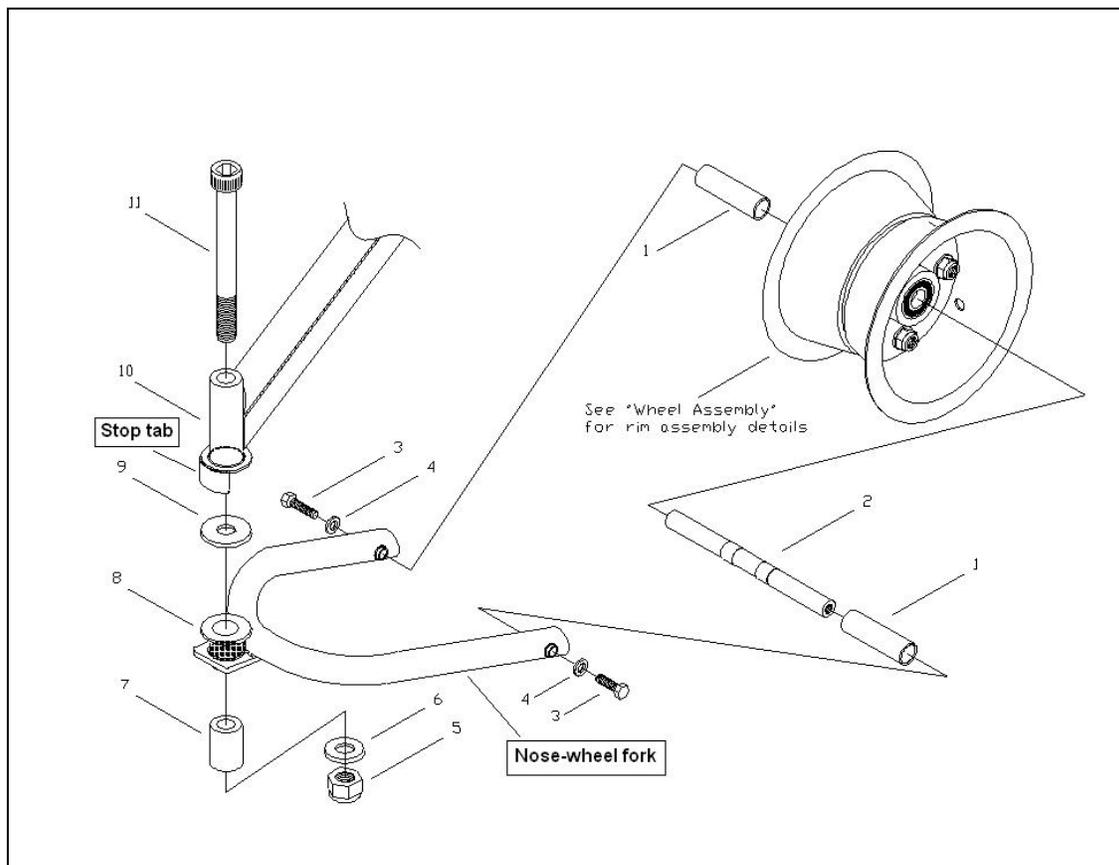
Nose landing gear fork assembly

The nose-wheel fork stop tab limits left and right castoring of the nose-wheel in order to maintain propeller tip clearance. See diagram on the next page.

If a main-wheel brake is applied to lock the main-wheel and force a very tight turning circle the nose-wheel fork will contact the stop tab which will in turn exert a side load on the nose-strut. This side load can quickly become excessive and repeated turns like this will lead to cyclic fatigue on the weld points of the fuselage tabs. See diagram.

Incorporate an inspection of the nose-wheel fork stop tabs for signs of deformation due to forced small turning radius on every pre-flight inspection. Should deformation of the stop tab be found, the aircraft should not be flown until a full and detailed inspection of the fuselage tab weldments have been carried out. The belly fabric may have to be cut slightly in the area of the tabs to allow full inspection. Always taxi with full nose up deflection on the elevator (stick back) Restrict taxi turns to walking pace speed, particularly when taxiing down hill. If taxiing over uneven ground is unavoidable (aircraft rocks from side to side) taxi very slowly or better still shut down and manhandle the airplane, lifting weight off the nose-wheel.

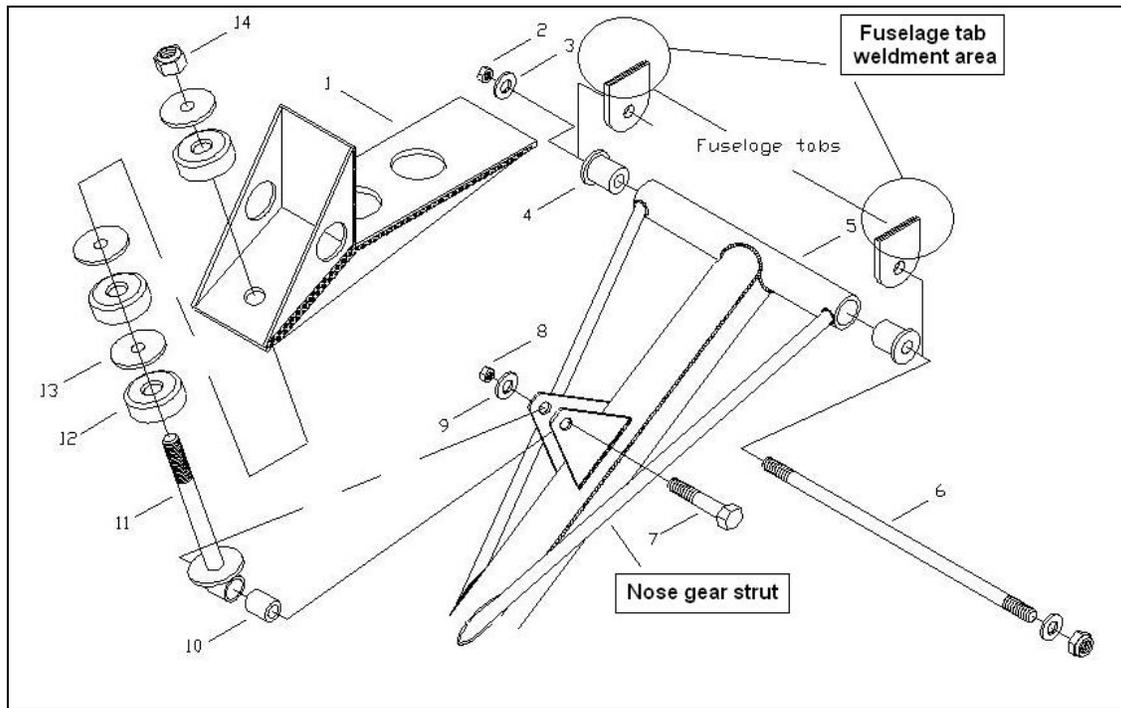
Nose landing gear top section

Failure of the fuselage tab weldments will lead to collapse of the nose-wheel strut, possible prop-strike, damage to the engine cowling and engine mount.
