**KITPLANES FOR AFRICA**

**SERVICE BULLETIN**

**BULLETIN NUMBER:** SB011

**SUBJECT:** Control column torque tube cracks

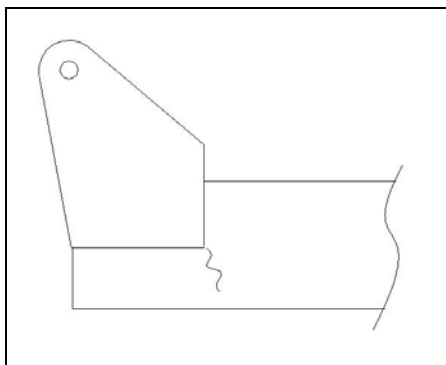
**Problem:** Cracks have been found on two occasions on the FCC control column torque tube, left rear side.

**Solution:** Remove the blue bearing block and inspect torque tube for cracks at every 100 hour or annual inspection.  
If any cracks are found, send the part back to KFA for replacement or repair.
