## SERVICE BULLETIN

**BULLETIN NUMBER: SB019**

**SUBJECT:** Control rod-end failure

**APPLICABILITY:** All KFA aircraft

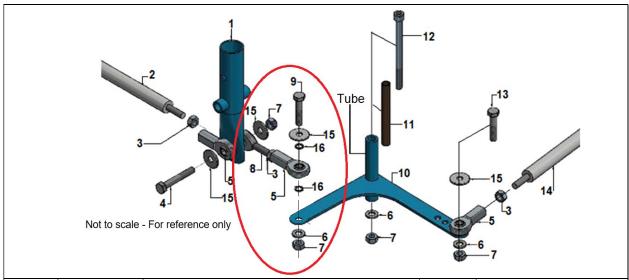
**Problem:** There was a recorded case of a Bushbaby loosing aileron control during taxi due to rod-end bearing failure. The failure occurred in the male bearing between the FBC-1 bell crank and the FCS-A control stick housing.

The eyes of the two rod-end bearings allow the control stick to move freely forward and aft within a limited range. If this range is exceeded the bearings will be subjected to a twisting load. The thread on the male rod-end bearing is the weakest link in the assembly and will fail first. The amount of control stick travel is controlled by the two stop clamps, one either side of the FEV-1 bush on the FCT-7 elevator pushrod.

**Solution:** Inspect the two rod-ends for binding by moving the stick full forward and aft, the bearings must have slight free play at either end of the elevator travel. If there is no free play, replace the male rod-end bearing, install and rig the assembly according to the procedure below. If there is any doubt about the condition of the bearing, replace it!

1. Set the hose clamp limit stops on the elevator tube for the desired up and down elevator, normally 25° down & 30° up. If more up elevator is required then reduce the down travel

- 2. Thread the N006 locknut onto the FC-2 male rod-end bearing, thread the FC-1 and FC-2 bearings together.
- 3. Install the assembled bearings in position, replace the B0625 bolt with a 6x40 (B0640) bolt and fit an M6 fender washer (FW006) and a ø 8 × 3mm brass bush (BB8003) (number 16 in the sketch below) on both ends of the bearing, on the top and the other between the bearing and FBC-1 aileron bell crank as in the sketch below.
- 4. Move the stick full back until the stop is engaged. Rotate the rod-end bearing forward and lock the lock nut. Move the stick fully forward and check that there is still free play in the rod-end.
- 5. When rigging is complete, mark the FC-2 rod-end thread for future inspection to ensure the locknut remains set.
- 6. Record the replacement/ inspection in the logbook and have an AP inspect and sign out the work.
